WOOD DESTROYING PESTS AND ORGANISMS INSPECTION REPORT

| BUILDING NO. 1439 | STREET, CITY, STATE, ZIP Tunnel Rd , Santa Barbara CA 93105 | Date of Inspection 10/31/2017 | No. of Pages 4 |

| General Description: Two story stucco frame residence, tile roof, concrete slab, attached garage. | Inspection Tag Posted: Attic |

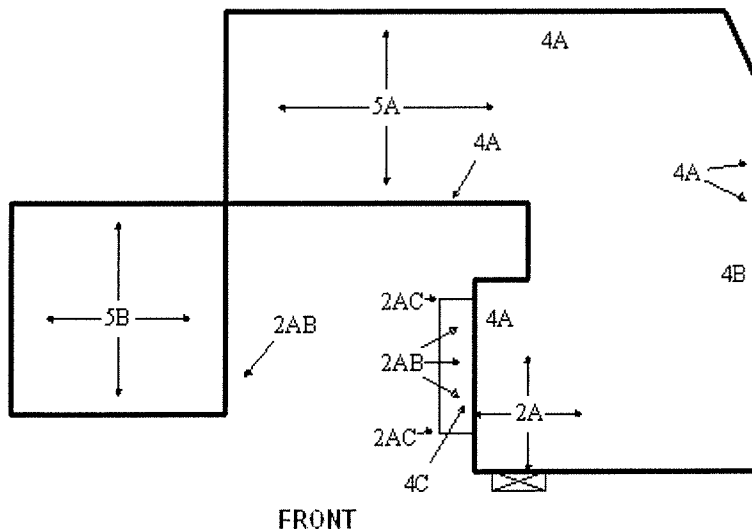
**DIAGRAM NOT TO SCALE
 FINDINGS ARE AT APPROX. LOCATIONS**

ITEM 2A **Finding:** Evidence of drywood termites found in the attic and exterior as indicated on the diagram by 2A. Infestations appear to extend into inaccessible areas.

ITEM 2B **Finding:** Drywood termite damage found at the roof sheathing and rafter tail as indicated on the diagram by 2B.

ITEM 2C **Finding:** Drywood termite damage found at the balcony beams as indicated on the diagram by 2C.

ITEM 4A **Finding:** Moisture stains found at the walls and ceilings as indicated on the diagram by 4A.

ITEM 4B **Finding:** Plaster damage found at the upstairs bathroom ceiling as indicated on the diagram by 4B.

ITEM 4C **Finding:** Moisture stains found at the roof sheathing as indicated on the diagram by 4C.

ITEM 5A **Finding:** A portion of the attic was inaccessible for inspection due to heating ducts as indicated on the diagram by 5A.

ITEM 5B **Finding:** The garage attic was inaccessible for inspection due to lack of access opening as indicated on the diagram by 5B.

Recommendation: Vacate and seal the structure. Fumigate with Vikane or Master Fume (Sulfuryl Fluoride) and Chloropicrin (warning agent) for the extermination of drywood termites. Remove seal, air out the building, ready for occupancy. When possible, remove or cover accessible evidence. This company will not be liable for possible damage to plants, paint, roofs, T.V. antennas; reasonable care will be exercised. Fumigation cannot take place in strong winds or rain and will be rescheduled if there is inclement weather.

Recommendation: Remove damaged area and repair with wood filler as necessary. Ready for painter.

Recommendation: Any questions regarding this condition should be referred to a licensed contractor.

Recommendation: Others are to provide access to permit inspection. A supplemental report will be issued outlining findings and additional costs.
